Debris/Ice/TPS Assessment and Integrated Photographic Analysis of Shuttle Mission STS-83

**DEBRIS/ICE/TPS ASSESSMENT
AND
INTEGRATED PHOTOGRAPHIC ANALYSIS
OF
SHUTTLE MISSION STS-83**

4 April 1997

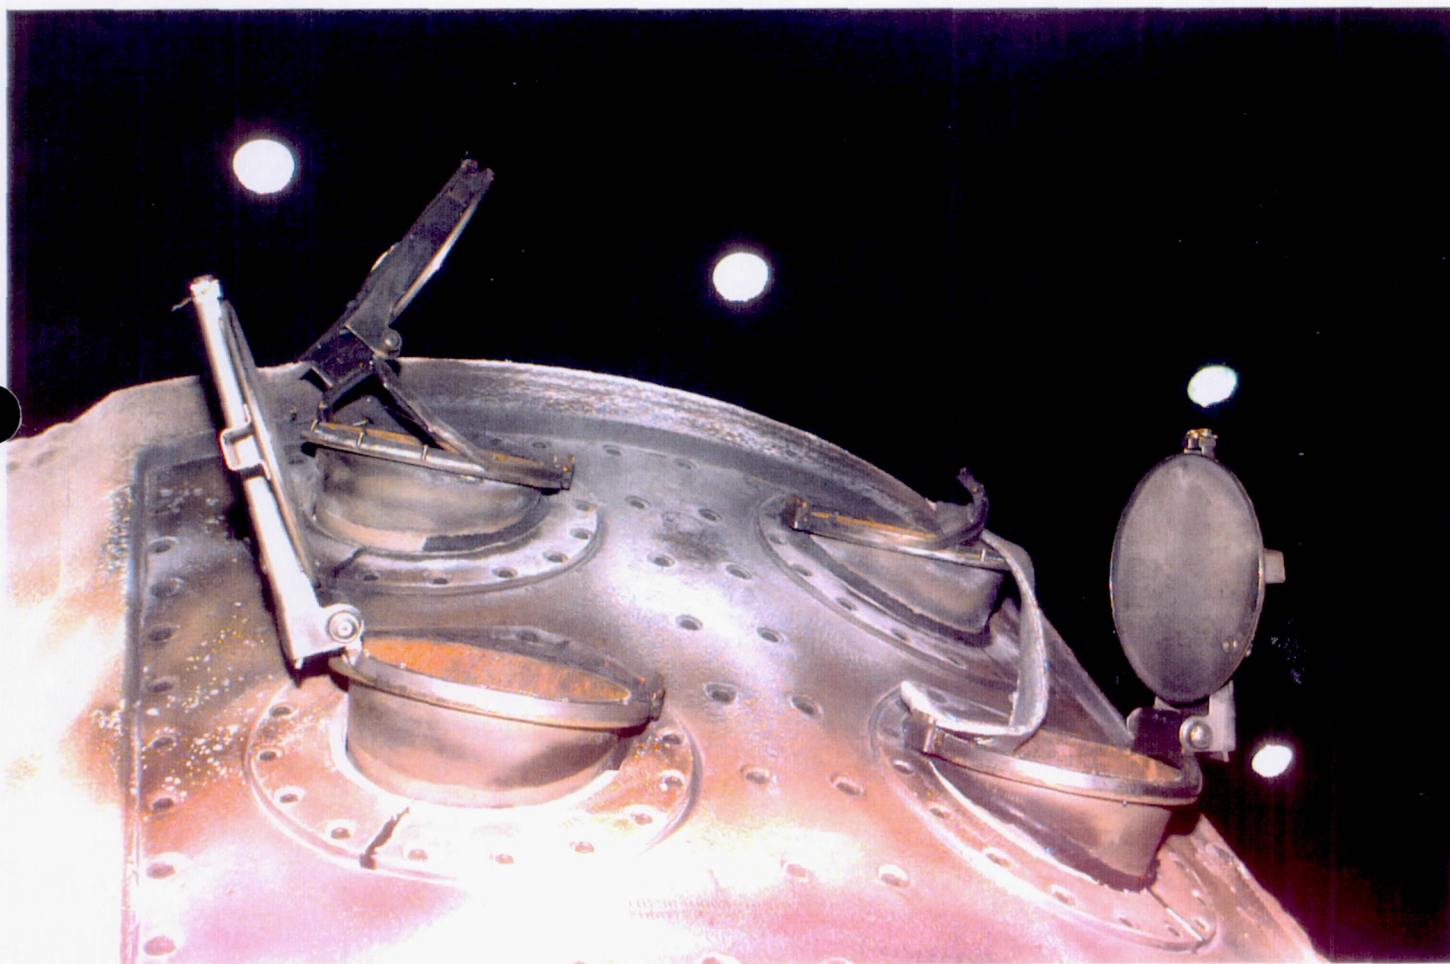
Photo 17: Right Frustum BSM's

All four BSM aero heat shield covers on the right frustum appeared to be locked in the fully opened position, though all four cover attach rings had been bent by parachute riser entanglement. The upper right cover was missing.

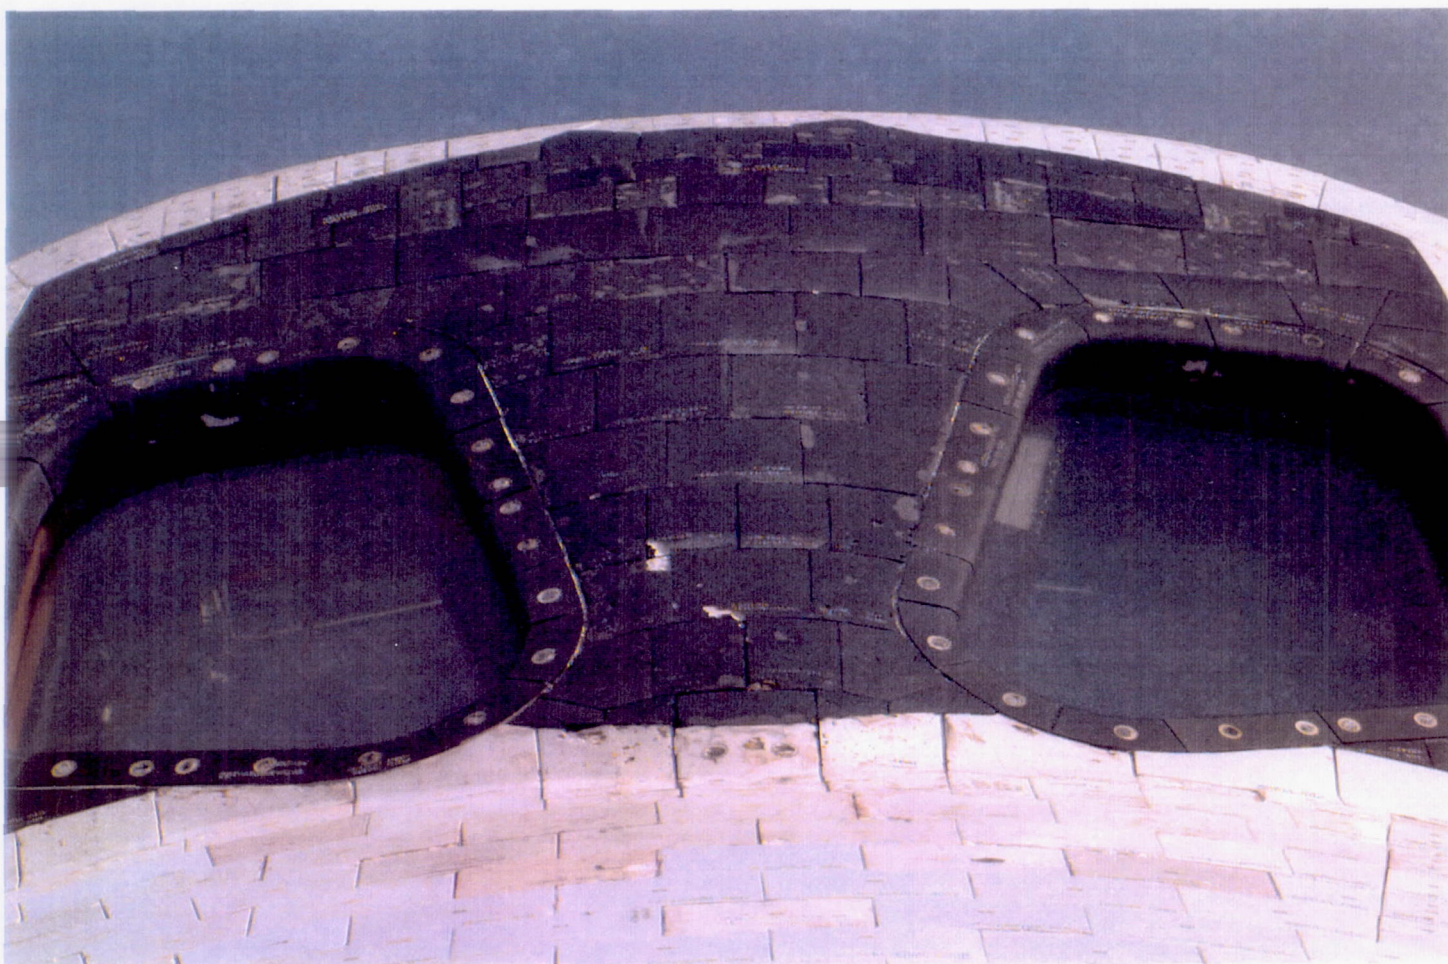
Photo 23: Orbiter Windows #3 and #4

Hazing and streaking of forward-facing Orbiter windows was typical. Damage sites on the window perimeter tiles appeared to be greater than usual in quantity and size. Two damage sites greater than 1-inch in size within a cluster of 11 hits were present in the black tile area between windows #3 and #4. These damage sites are believed to be the result of impacts from excessive RTV adhesive used in attaching paper covers to the FRCS thrusters.

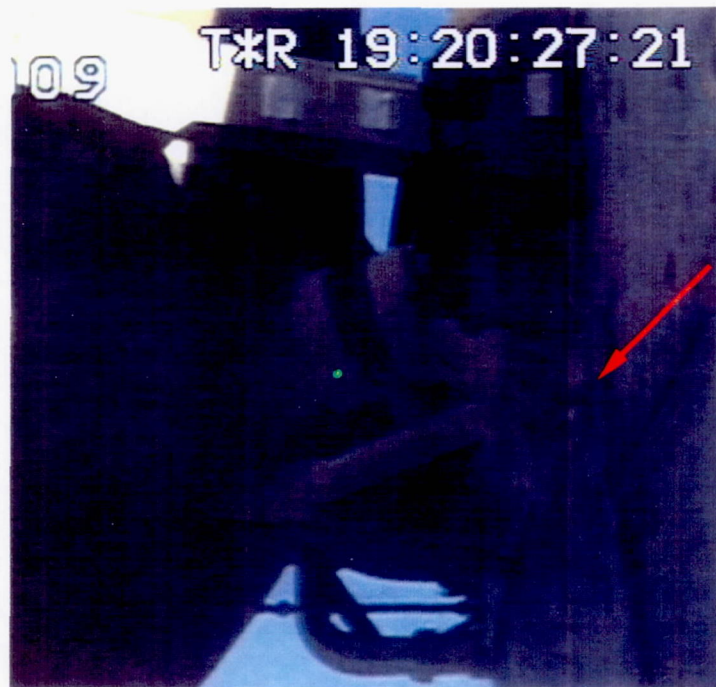
Figure 2.1 (A) Ice Debris Strike to Umbilical Well Door Sill

Multiple pieces of ice debris from the LH2 ET/Orbiter umbilical were seen falling past the body flap during SSME ignition. Ice debris was seen to strike the LH2 umbilical well door sill (19:20:27.7 UTC). No damage was noted (Camera OTV009).

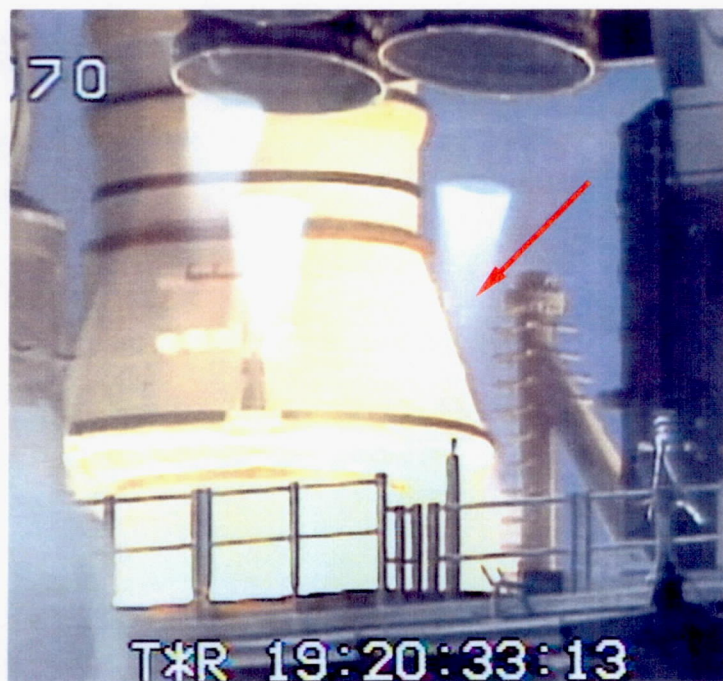
Figure 2.2 (A) Light-Colored Debris Near RSRB

Light-colored debris (probably umbilical ice) was seen near the RSRB aft skirt at 19:20:33.433 UTC (Camera OTV070).

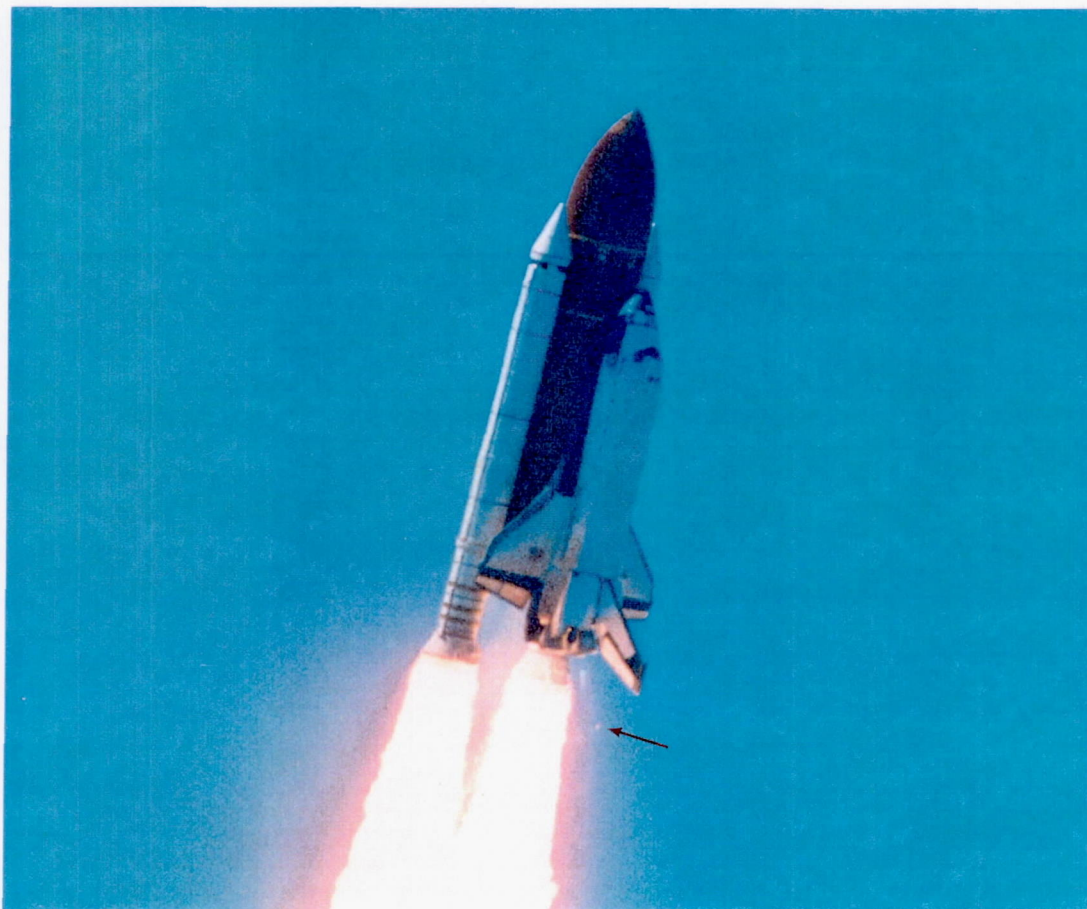
Figure 2.2 (C) Debris Aft of Vertical Stabilizer

A single piece of debris fell aft of the vertical stabilizer during ascent (19:20:49.550 UTC), (Camera E222).

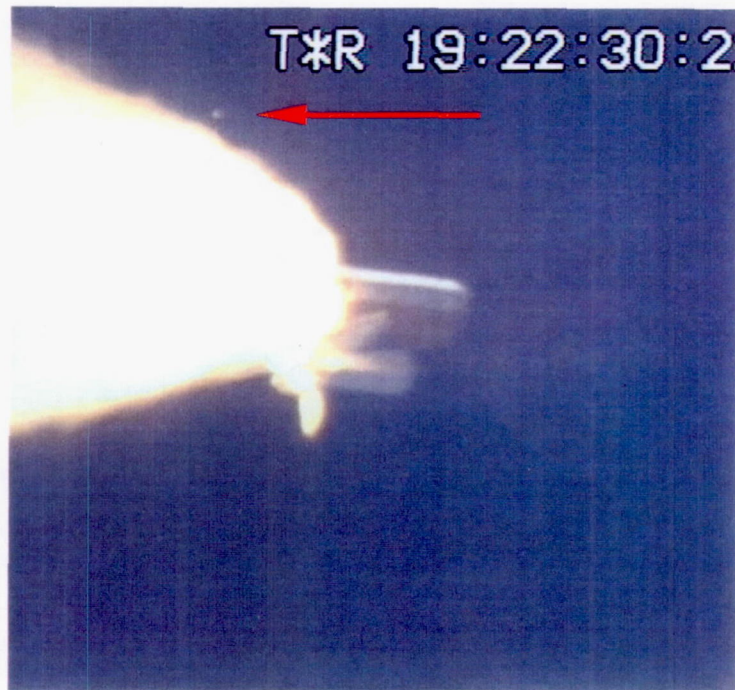
Figure 2.2 (D) Debris Near SRB Exhaust Plume During Ascent

Multiple pieces of debris (possible SRB aft skirt insta-foam) were seen falling along the SRB exhaust plume during ascent. The debris were seen at 19:20:50.433, 19:20:51.4, 19:20:53.2, 19:21:39.2, and 19:22:30.733 UTC (Cameras KTV4A, KTV13, KTV21A, ET204, ET212, E224).

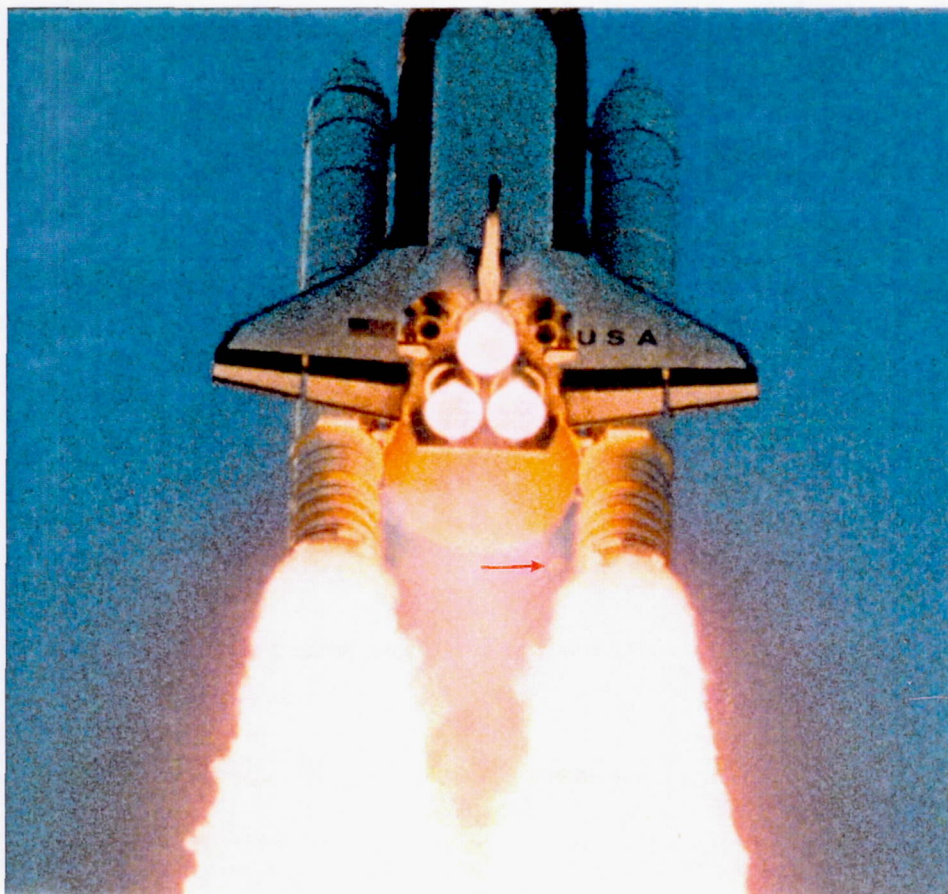
Figure 2.2 (E) Debris Near ET Dome and RSRB

Six relatively large pieces of debris (probably umbilical purge barrier material), first seen near the ET aft dome and the RSRB aft attach ring, fell between SRBs during ascent (19:20:50.604 UTC), (Cameras E52, E54).

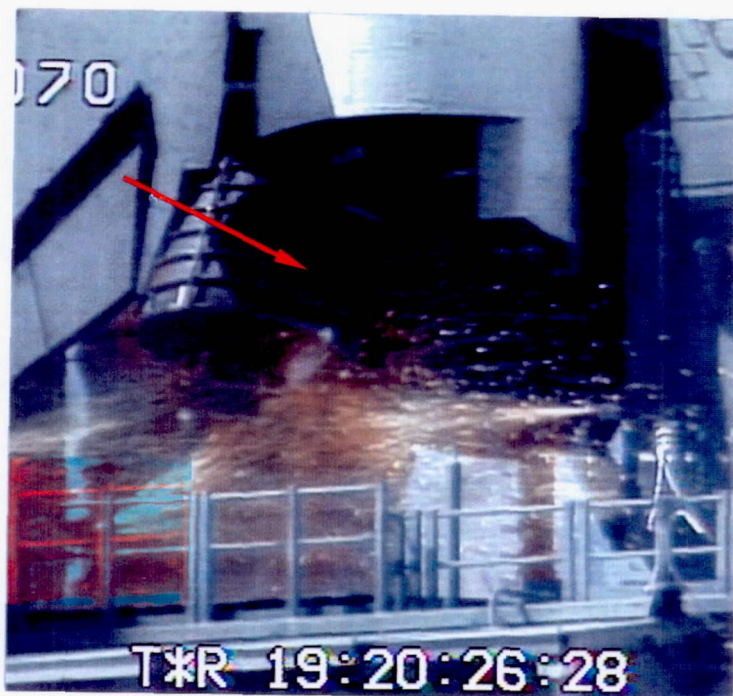
Figure 2.3 (A) Orange Vapor During SSME Ignition

Orange vapor, probably free burning hydrogen, was seen above the SSME rims and near the base of the vertical stabilizer during SSME ignition (19:20:26.9 UTC). Orange vapors have been seen on previous missions (Camera OTV070).

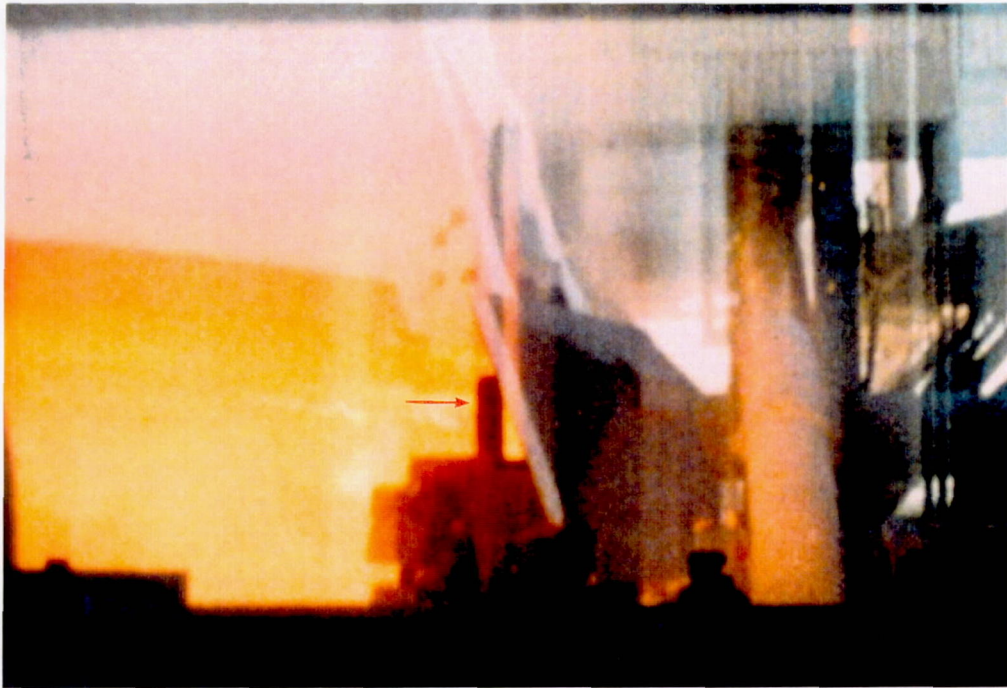
Figure 2.3 (B) Holddown Post M-7 Bolt Hang-Up

A bolt hang-up was seen at the LSRB holddown post M-7 at liftoff (19:20:32.611 UTC), (Camera E11). An unidentified piece of debris fell past the HDP shoe at 19:20:32.601 UTC. SRB holddown bolt hang-ups have been seen on six of the last eleven previous missions. See Table 2.3 (B). No follow-up action was requested.

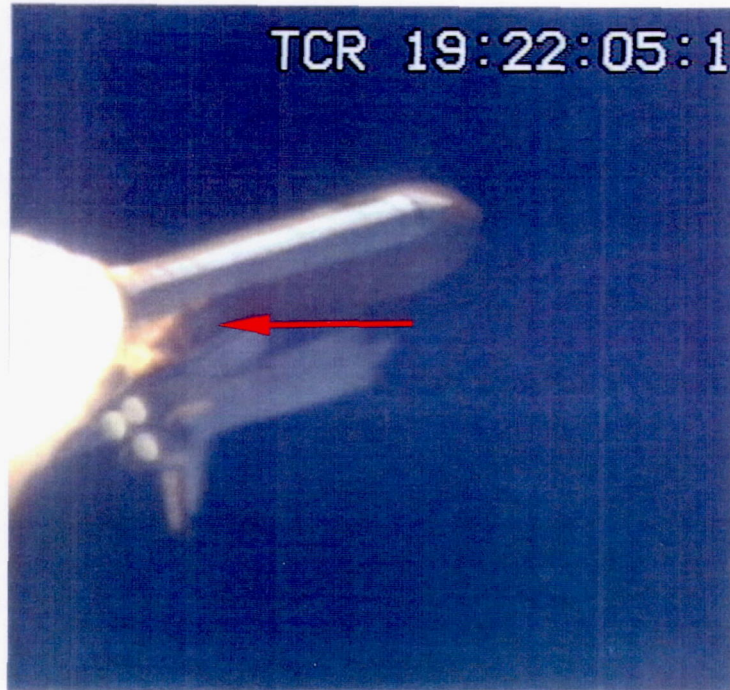
Figure 2.4 Recirculation at Aft End of Vehicle

Recirculation, or the expansion of burning gasses at the aft end of the vehicle, was seen during ascent (19:22:04.7 - 19:22:18.1 UTC). Recirculation during this time period has been seen on previous missions (Cameras KTV13, ET204, ET208, ET212, E212).

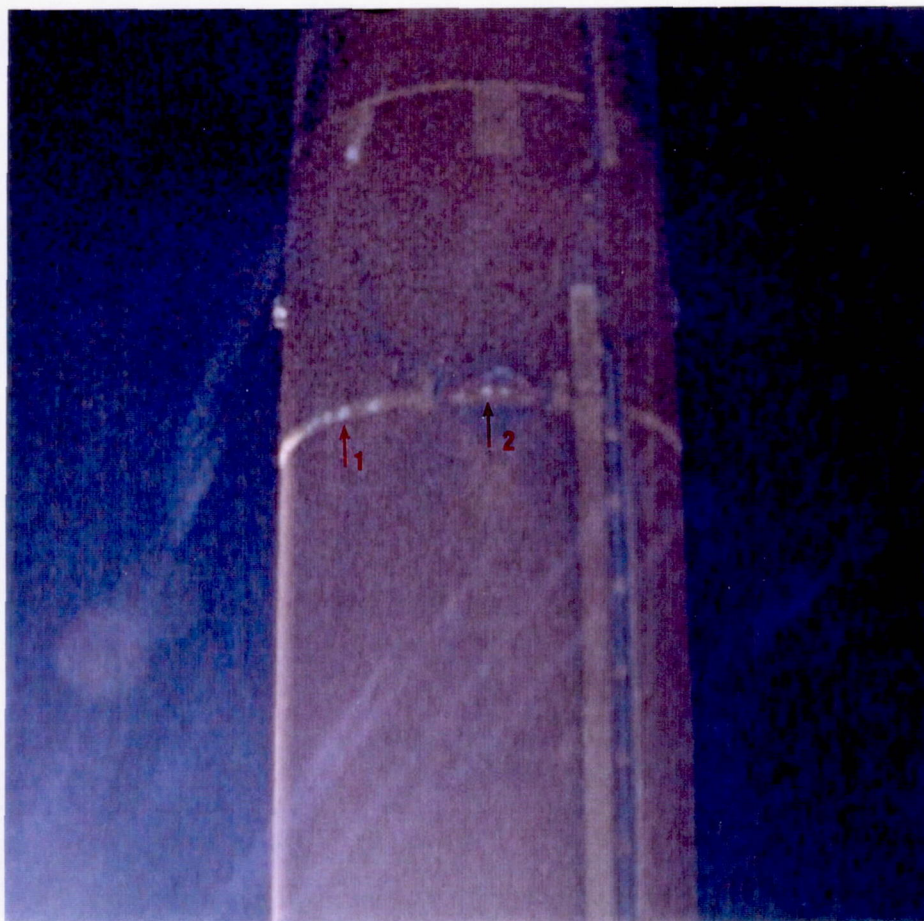
Figure 2.5.1 (A) Closeout Flange Divots

Four TPS divots, approximately nine inches in size, were seen on the intertank-to-LH2 tank flange closeout on the -Y+Z axis (1). Three additional TPS divots (2), approximately six inches in size, were seen on the intertank-to-LH2 tank flange closeout between the bipod legs (2). (10mm lens, frame 10753).

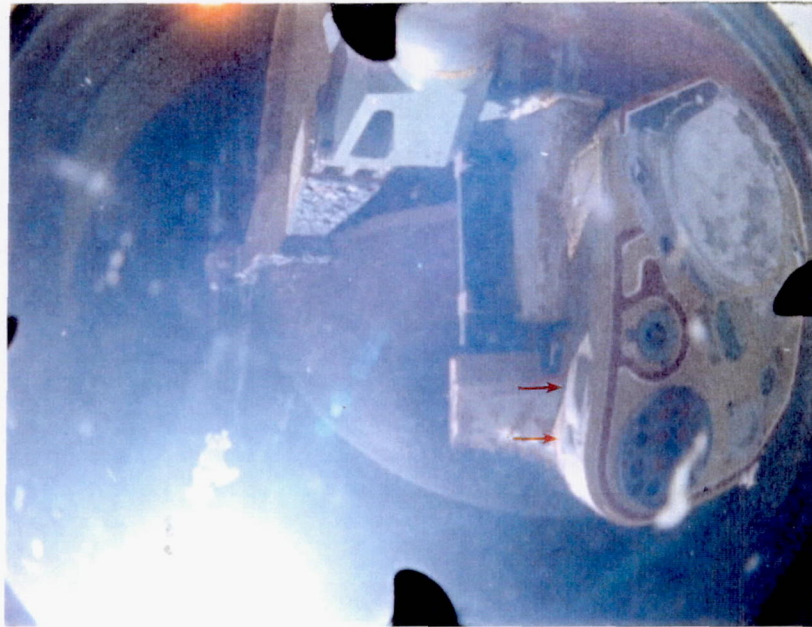
Figure 2.5.1 (B) Blisters on LH2 Umbilical Fire Barrier

Two larger-than-usual areas of blistering were seen on the fire barrier on the outboard side of the LH2 umbilical (5mm lens, frame 5141).
